Saltstone Disposal Unit 6

Jon Lunn SDU 6 Project Manager

September 26, 2016

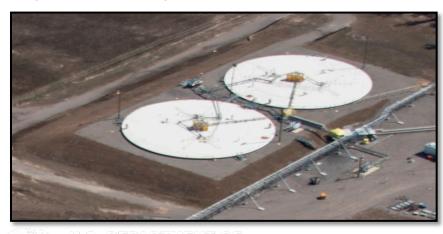
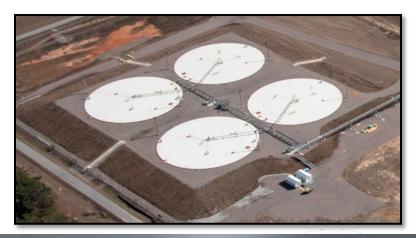
The Next Generation SDU

- SDU 2, 3 & 5 consists of two reinforced concrete cells A and B
- Each cell is 150' in diameter, with a side wall height of 22' and a center height of 23.5', capable of storing ~3.0 million gallons of grout
- These cells are backfilled below grade with the cell roof at grade level
- SDU 2 was placed into service in 2011 and was filled in 2014
- SDUs 3&5 were placed into service in 2015 and plan to accept Saltstone grout through 2017

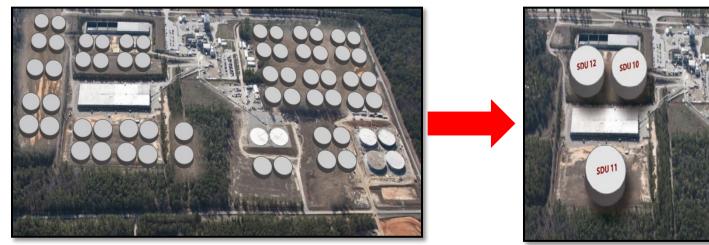
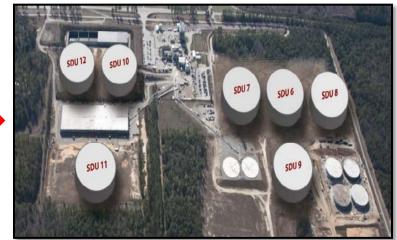
- SRR provided a Cost Savings Initiative to the DOE on future Saltstone Disposal options
- The team determined the Mega SDU is more economical
 - Life cycle cost savings estimated by DOE to be approximately \$300M based on 7 mega SDUs vs. 82 smaller SDUs

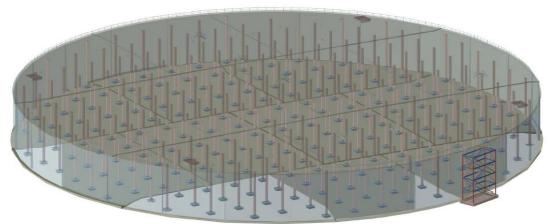
3D Model

Saltstone Disposal Unit 6

Tank Feature	Quantity
Foundation (10 sections)	4,482 cubic yards
Wall Panels (25 each)	2,636 cubic yards
Columns (208 each)	1,004 cubic yards
Roof (10 sections)	4,536 cubic yards
Pre-Tension Wire Strand	289 miles
Shotcrete	294 cubic yards

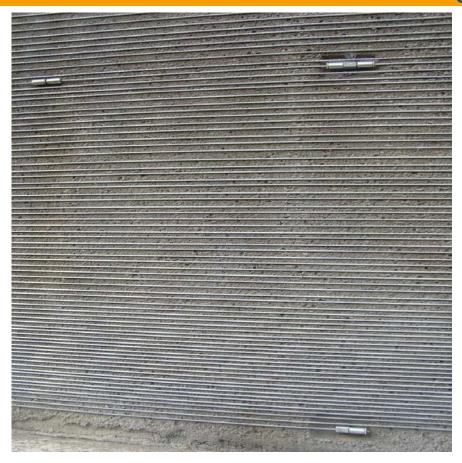
SDU 6 Circumferential Pre-stressing

Pre-stressing machine

- Machine Performs 3 functions:
 - Hydro-blasting, circumferential pre-stressing, and shotcreting

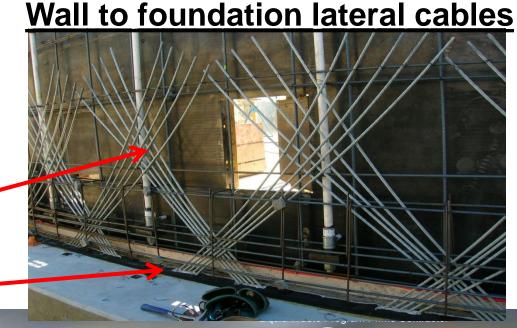
Seismic Design

Wall to roof shear connection

Lateral Cables

Bearing Pads

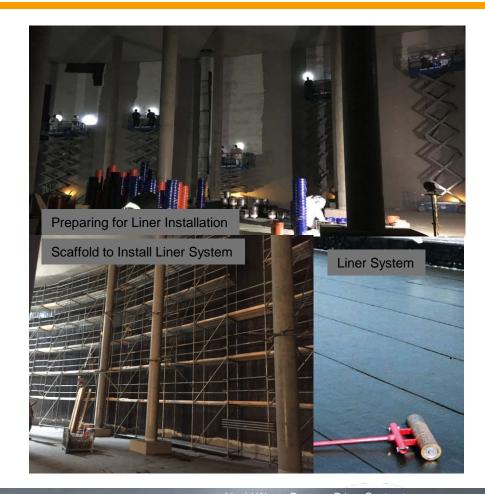
Cell Status

- Cell failed hydrotest due to leakage from floor. (November 2015)
- Attempted repair using epoxy injection. (December 2015)
- Systems Engineering Evaluation (SEE) conducted to determine path forward. (February-March 2016)
- Engineering Study Report (ESR) completed in May recommending an elastomeric liner system (REMA 4CN) to provide leak tightness.
- REMA 4CN product successfully passed 1000 hour salt solution soak test.
- REMA 4CN product procured and installation underway.

- Project baseline included installation of an interior coating system to protect the concrete from Sulfate attack per ACI code requirements.
- Water tightness test was performed prior to application of internal coating to pursue a future opportunity to eliminate coating if sulfate testing showed positive results.
- Water tightness test did not pass with the very stringent requirement of zero leaks.
- Robust coating/liner system being installed to achieve water tightness.

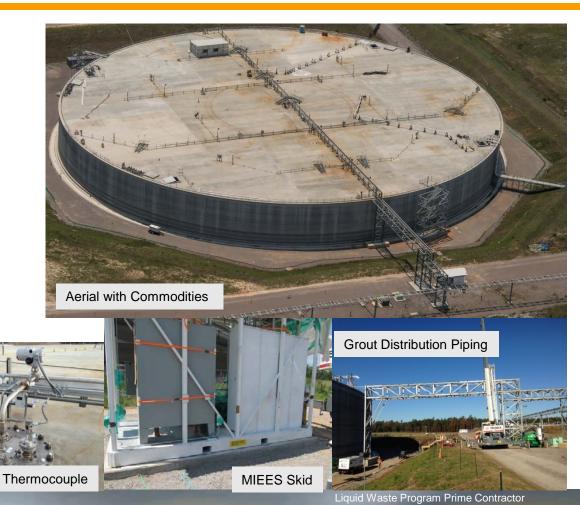
Balance of Plant (BOP)

- Grout distribution system (complete)
- Drain water system (complete)
- Modular instrument / Electrical equipment skid (MIEES) (complete)
- Temperature monitoring (complete)
- Power, cameras, lighting (working)
- Passive Ventilation (working)
- Facility tie-ins (forecast December 2016)

- Grout Pipe 1200 LF
- Drain water Pipe 1200 LF
- Conduit / Cable Tray 6,300 LF
- Cable & Wire 43,920 LF
- Pipe Bridge 36K lbs
