Z Area Salt Disposal Facility Update Presentation to the Waste Management Committee

August 12, 2014

Defense Waste Processing Facility/Saltstone Facility Manager

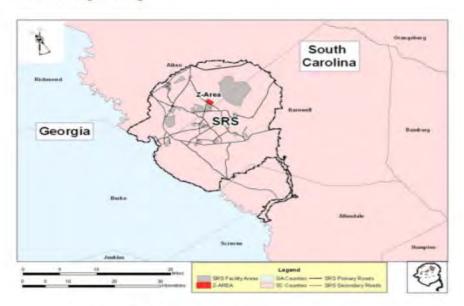
Location of Saltstone Disposal Facility at SRS

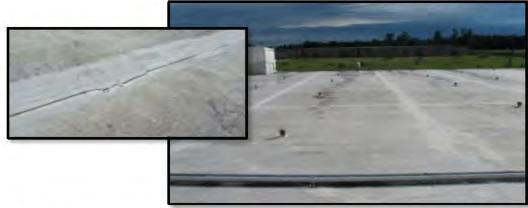
- Cracks in Vault 4 roof allowed rainwater to migrate into the vault
- Liquid collected in the narrow annular space between the grout waste form and the vault wall
- Contaminated liquid could weep through construction joints or cracks that existed in the vault wall

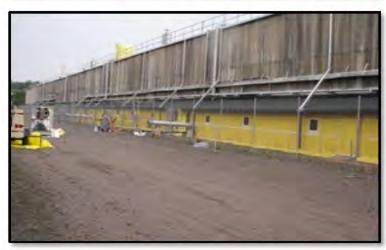
- Pour minimum "clean cap" to Vault 4 cells as necessary to establish roof dose rate
 - <5 mrem/hr for worker exposure control
- Install elastomeric roof covering on cells D, E, F, J, K, and L
 - Cells A, B, C, G, H, and I are already coated/sealed
- Continue maintenance on roof and weather enclosures
- Continue to manage drain water levels
