In-Service Inspection Program for the SRS Waste Tanks: Update

9/29/09

Karthik Subramanian
SRR, Office of the Chief Engineer

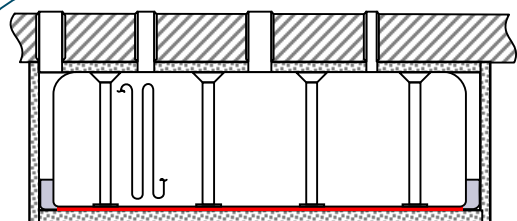
Type I (12)
Old Style
750 kgal
1951-1953

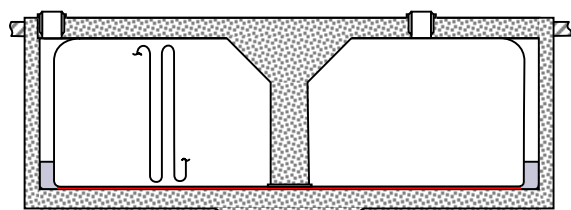
Type II (4)
Old Style
1.0 Mgal
1955-1956

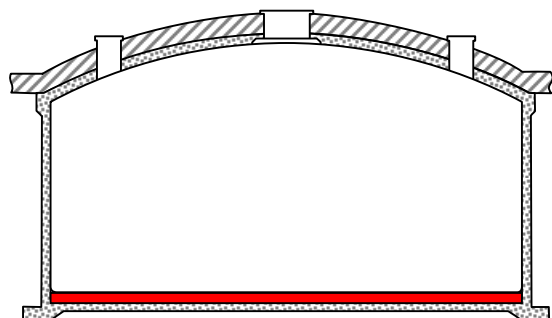
Type IV (8)
Old Style
1.3 Mgal
1956-1960

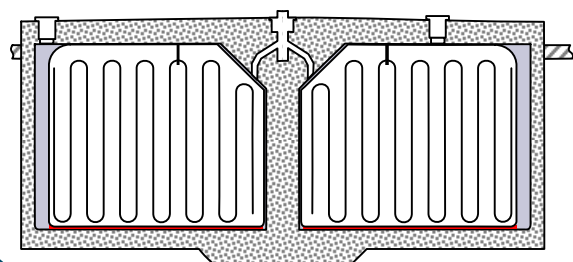
Type III (27)
New Style
1.3 Mgal
1966-1981

- (24) Old Style Tanks
 - Type I/II: partial secondary containment
 - Routine visual inspections of annulus
 - Monitor and visually inspect during waste removal activities
 - Type IV: single shell tanks (SST)
 - Routine internal visual inspections
 - Up to 50 years old
 - Do not have full secondary containment
 - (2) have been closed
 - No active leaksites today
- (27) New-Style Tanks
 - Full secondary containment
 - No leakage history
 - Receive all new waste
 - Used for all processing activities
 - Comprehensive inspection program
 - Visual inspections
 - Volumetric inspection

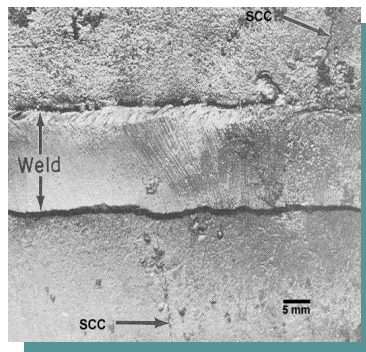
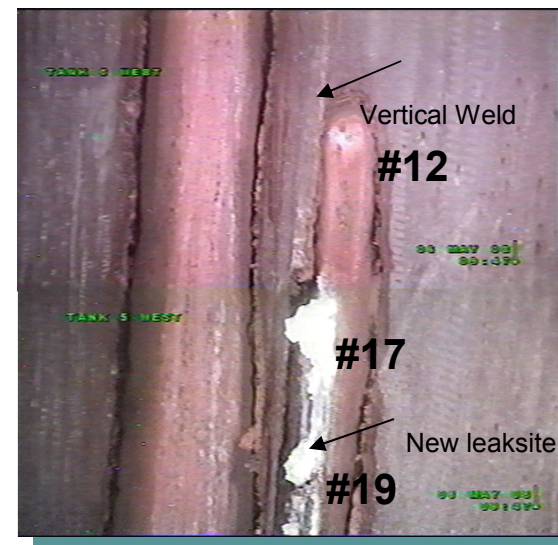
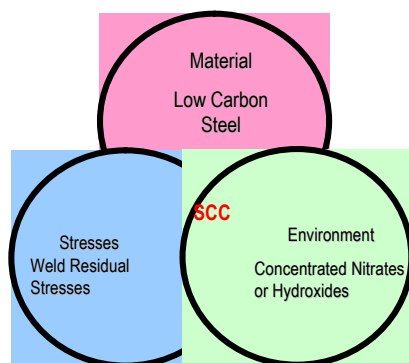
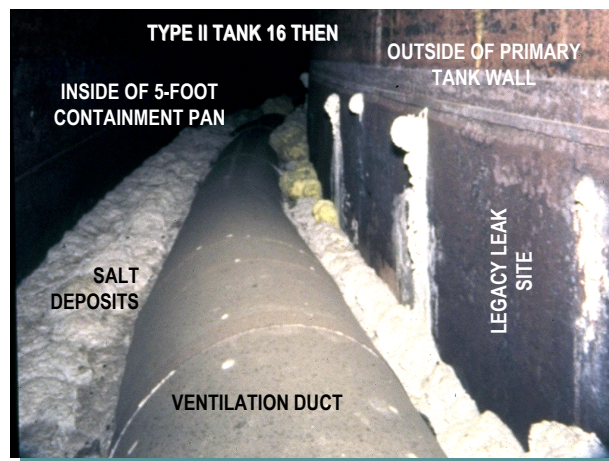
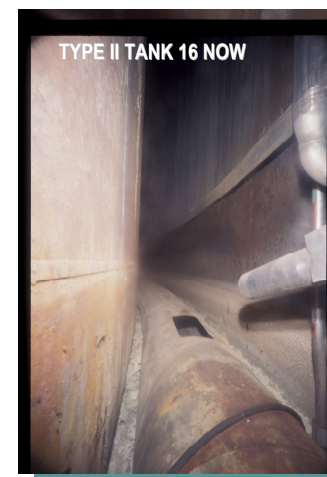
Degradation Mechanisms

- Primary mode of degradation is nitrate-induced stress corrosion (SCC) cracking near fabrication welds or repair welds
- Occurred early in service in non-stress relieved Type I/II Tanks
- Type III Tanks have no known leaksites
 - Better materials of construction
 - Post-weld heat treatment to relieve weld residual stresses
- Corrosion control program to preclude further degradation

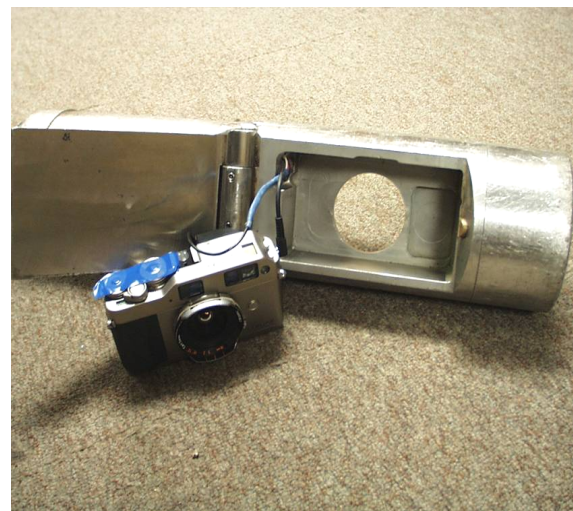
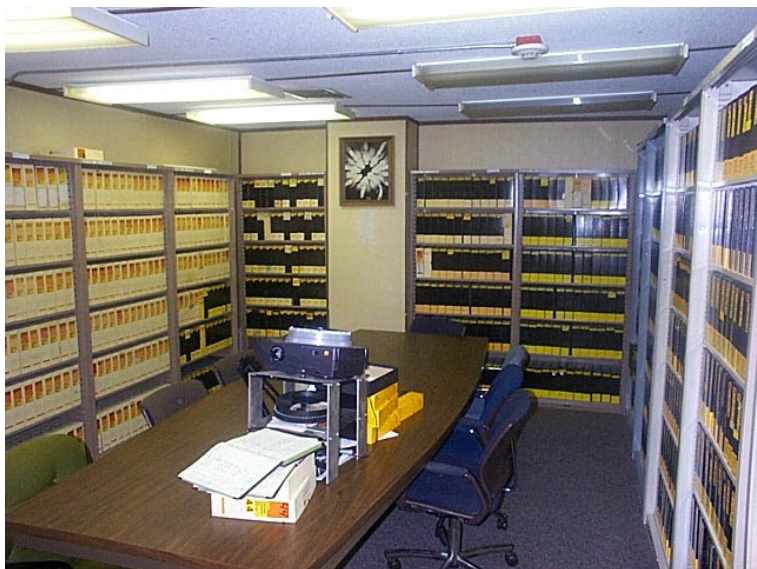
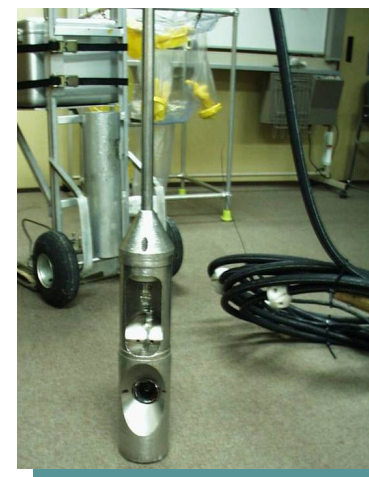
Visual Inspections

- Visual evidence of changes in tank component appearance
 - Leak sites
 - Corrosion
 - Abnormal conditions

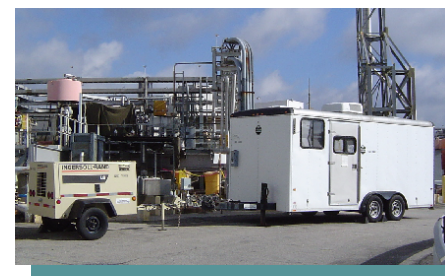
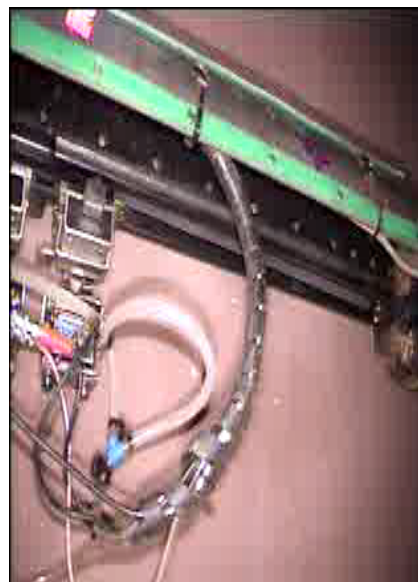
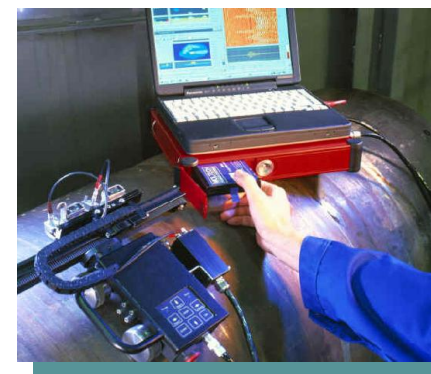
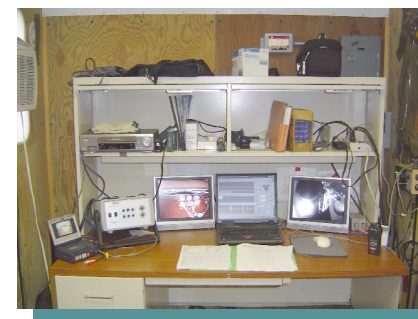
- Access thru small-diameter riser
- On-board cameras

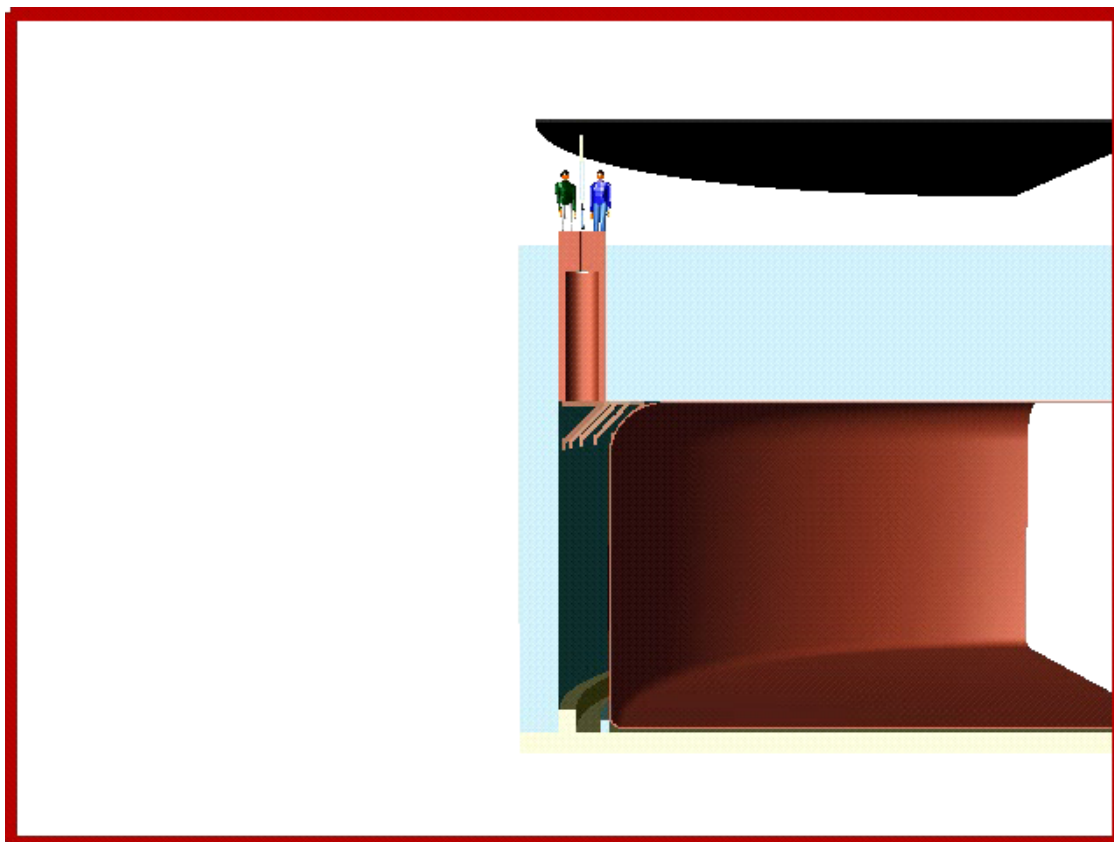
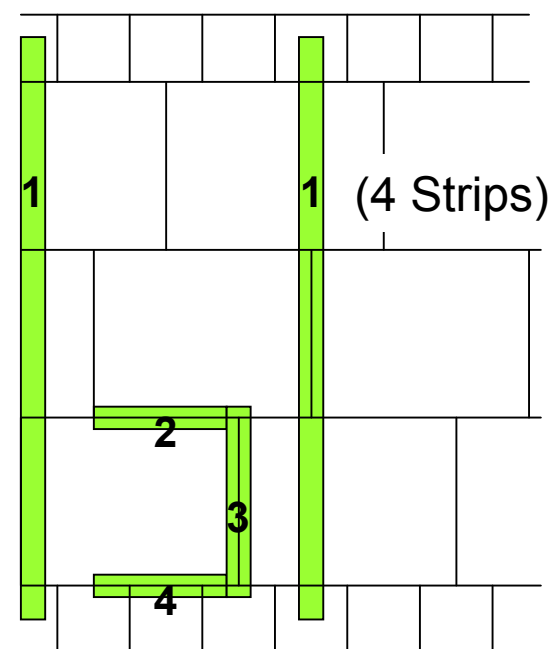
Ultrasonic Inspection of a Tank

Probe travels over
1 mile during a
tank inspection

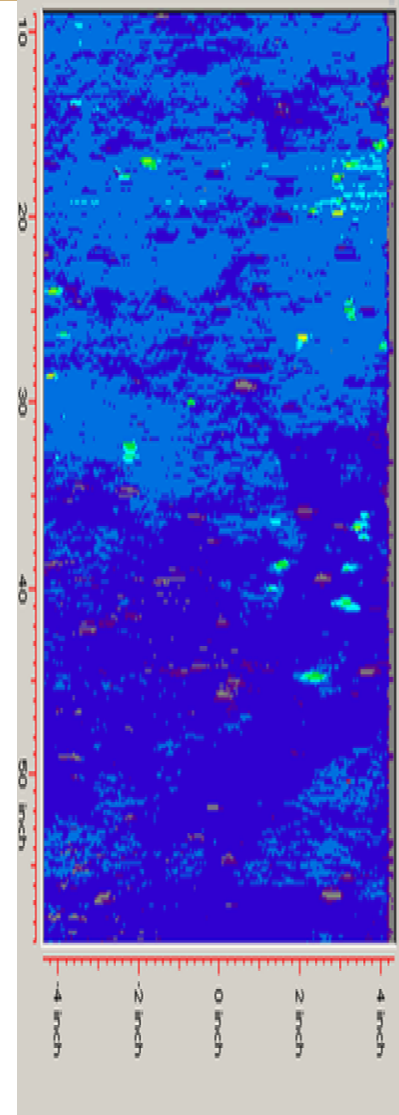
Tank 49
2004

- Incipient pitting is a term used to describe small pit-like indications prior to them becoming reportable or actionable
- The term describes a shallow indication
- The term does not necessarily imply that the pit has recently developed or that it is still growing
- Many incipient pits may have developed pre-service
